Manhole Inspection Summary

Manhole # S33II1012MH

Insp Date: **3/27/07 3:23 PM**

Location Address: **4200 ST PAUL ST**

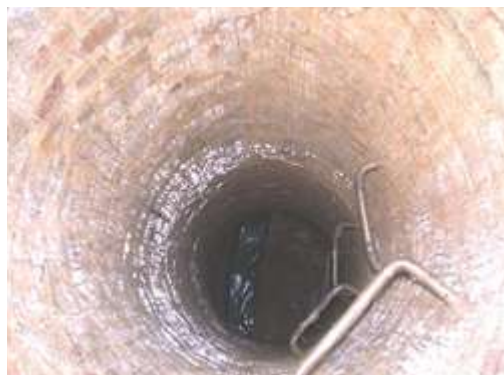
Top View

Bench debris.

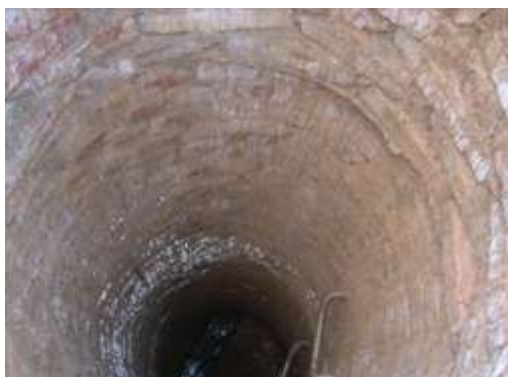
Defect

Infiltration: ☐ None ☒ **Joint** ☐ Cracks ☐ Mortar ☐ Roots ☒ **Wall**

Infiltration: ☐ None ☐ Joint ☐ Cracks ☐ Mortar ☐ Roots ☒ **Wall**

Corbel and Barrel infiltration.

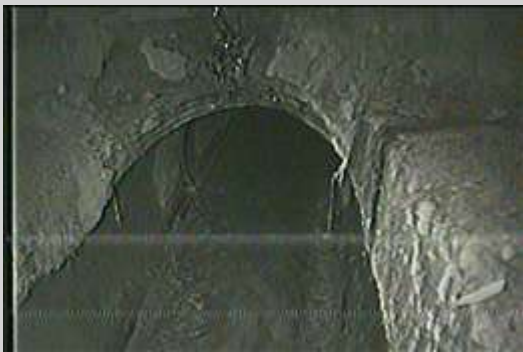
12 in. Circular Gravity Sewer Pipe Out @ 12 O'Clock

Infiltration: **Evidence** Pipe Seal Cond: **Unknown**

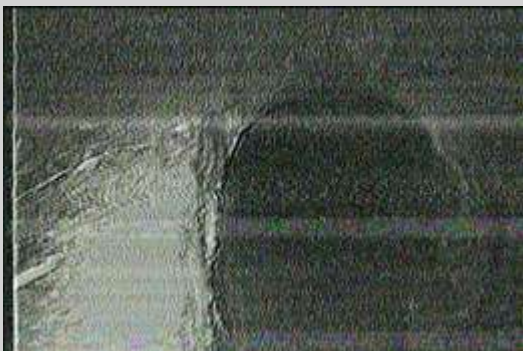
12 in. Circular Gravity Sewer Pipe In @ 5 O'Clock

Infiltration: **None** Pipe Seal Cond: **Unknown**
